CONSOLIDATED SEWER MAINTENANCE DISTRICT CONDITION ASSESSMENT PROGRAM REPORT PROJECT Y0TV0910B

CONDITION ASSESSMENT REPORT
COUNTY OF LOS ANGELES DEPARTMENT OF PUBLIC WORKS
CONSOLIDATED SEWER MAINTENANCE DISTRICT

**Infrastructure Inspection Reports
for Grades 4 and 5**

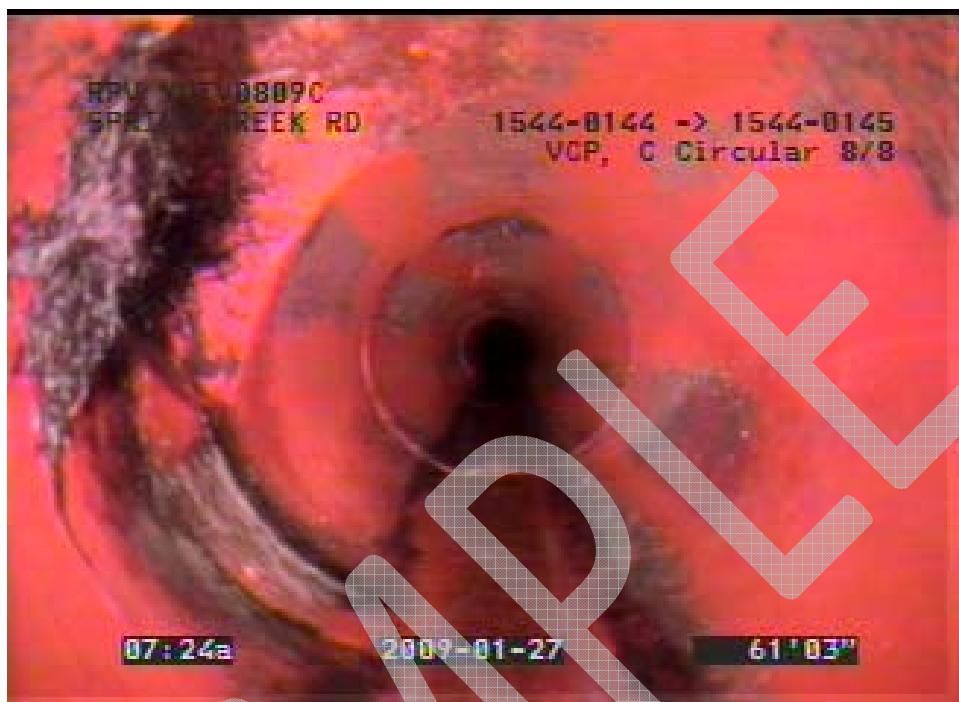
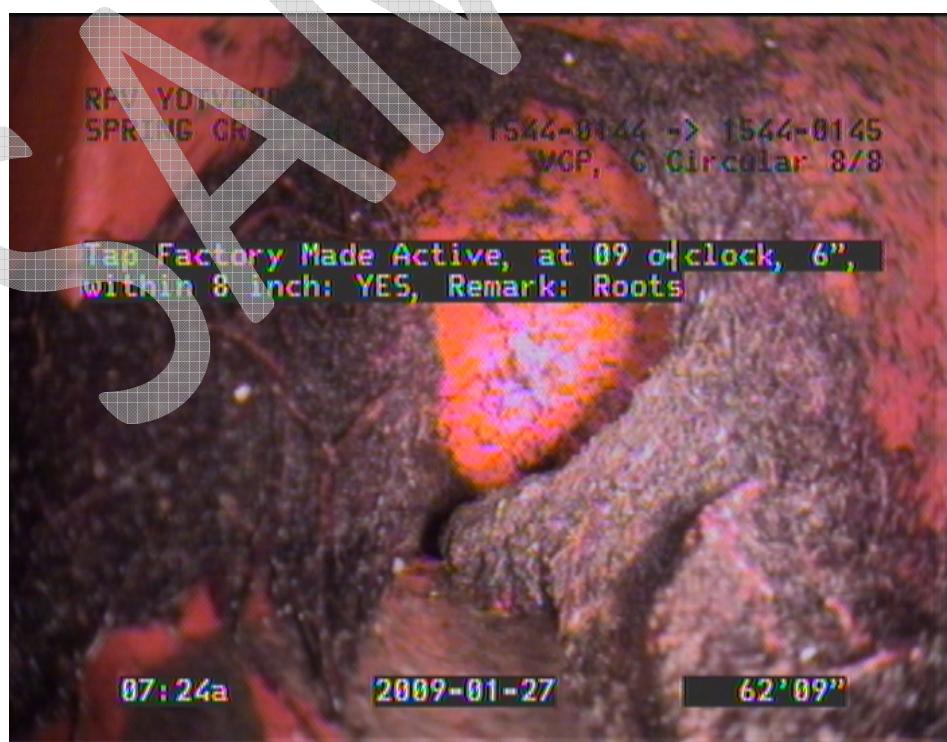
XXXX
Roots at Lateral Connection

Since the CCTV inspection, the sewer mainline has been cleaned and blockages from root growth have been removed; however, the root blockage in your sewer lateral is still present. As the property owner, you are responsible for the entire length of the sewer lateral, which includes the portion that extends beyond the property line into the public right of way. We request that you contact a qualified plumbing contractor to service your sewer lateral within 90 days to remove roots and any other obstructions that may cause a sewage backup.

For your reference, we have enclosed photos of your lateral connection showing the presence of the root blockage. Also enclosed are some literature on ways of minimizing sewer overflows and damage to your home.

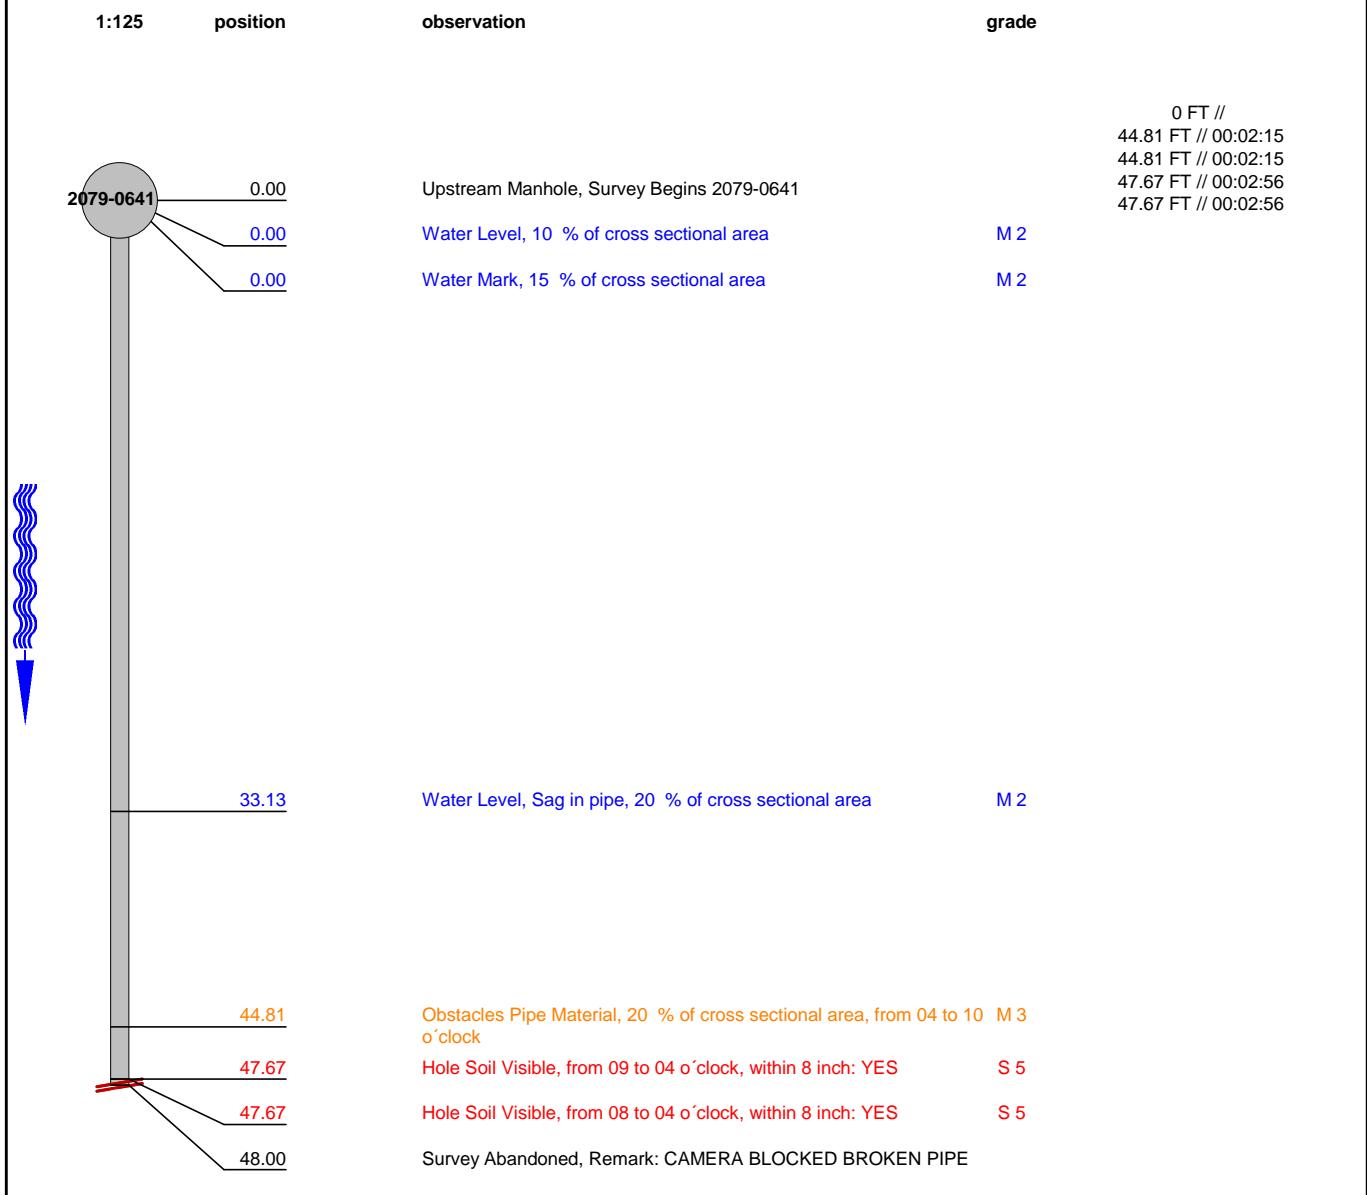
Remark:: **BROKEN PIPE**

QSR	QMR	SPR	MPR	OPR	SPRI	MPRI	OPRI
5200	3123	10	9	19	5	2.25	3.17

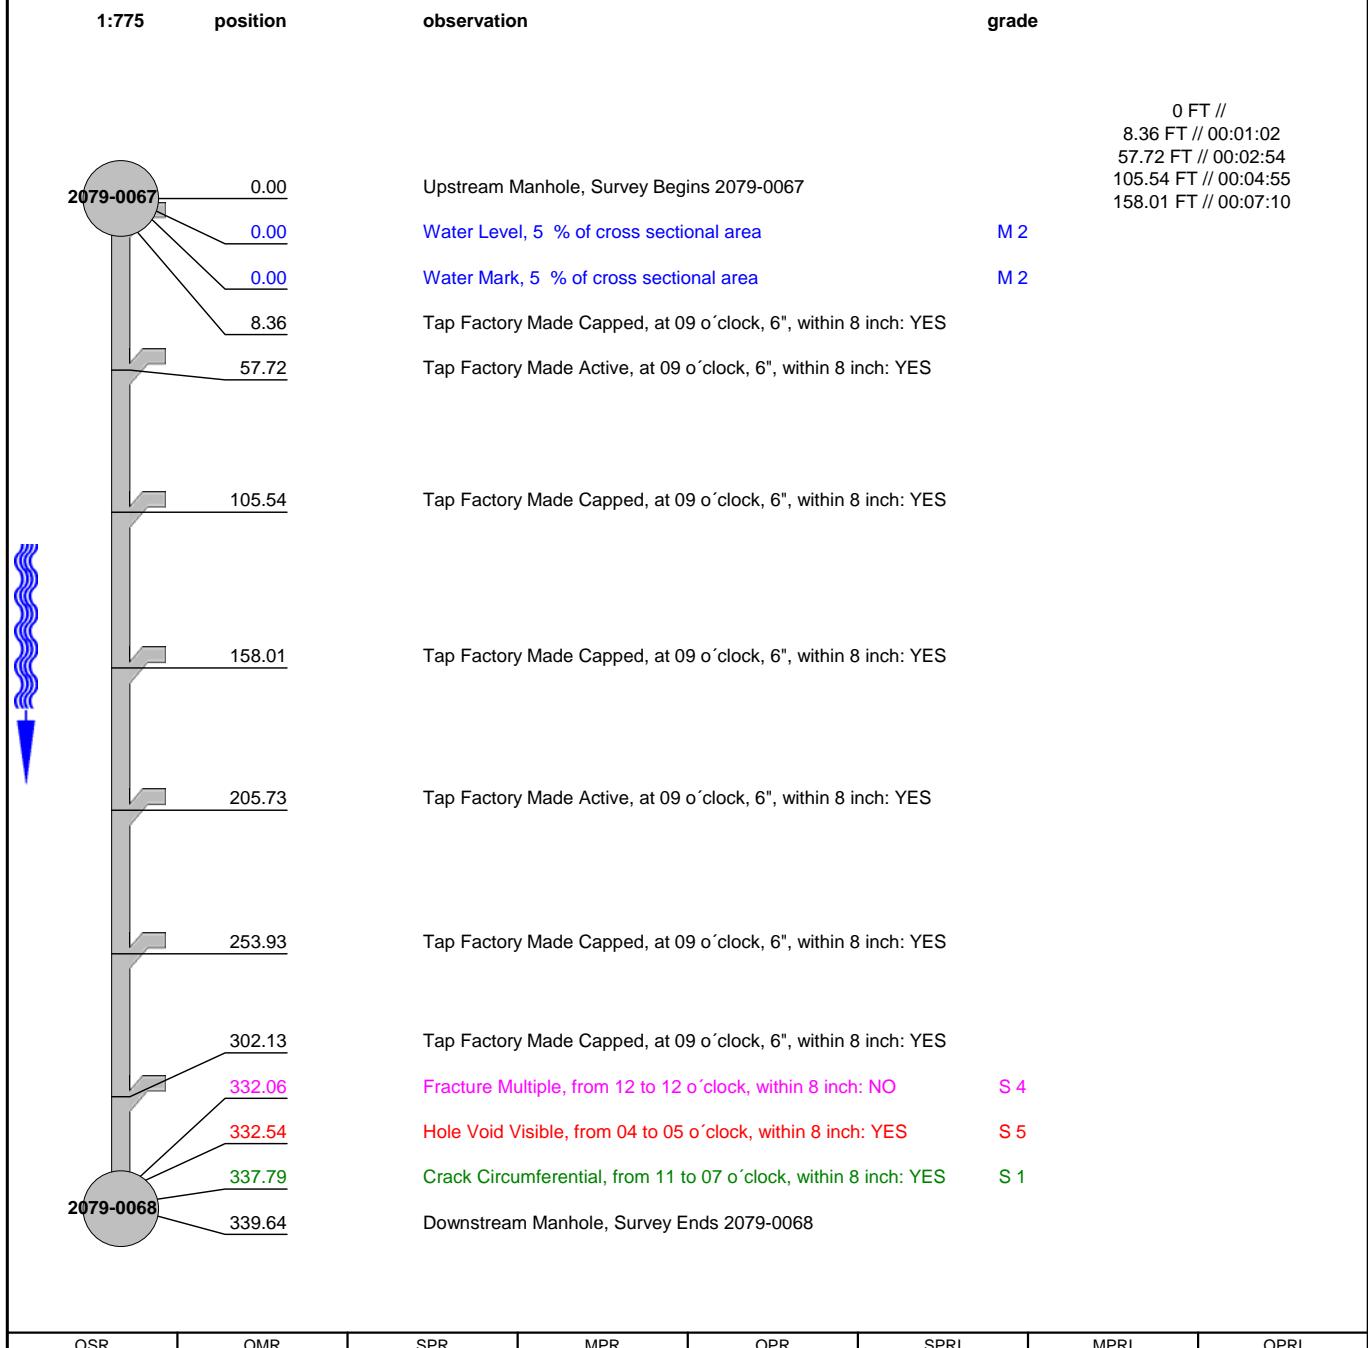
Remark:: HOLE AT 332FT

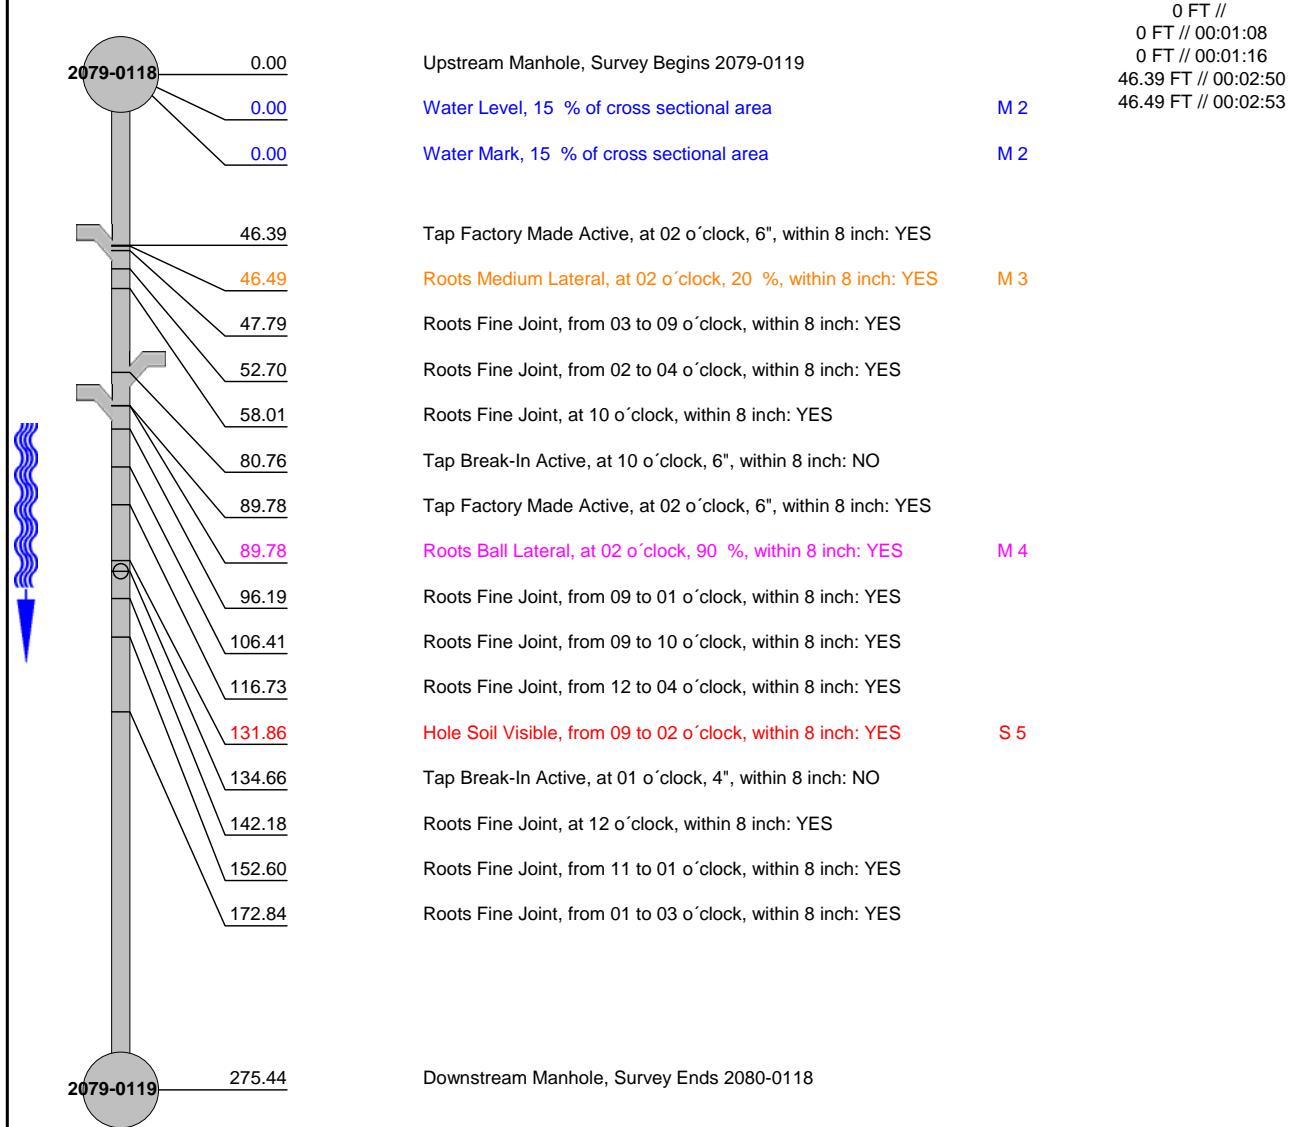
Street: GREENSTONE AV	Flow Control: N Not Controlled	Start MH: 2079-0118
City: SFS	Year Renewed	End MH: 2079-0119
Location Code: C Light Highway	Tape/Media #:	pipe length: 275.44 ft
Reason for inspection: F Routine Assessment	Dia/Height: C Circular 8/8	
Use of Sewer: SS Sanitary	Material: VCP Pipe Length: 299	
Drain. Area: 0118/2079-0119/2079	Lining Method:	
Remark:: BROKEN JOINT	Category:

QSR	QMR	SPR	MPR	OPR	SPRI	MPRI	OPRI
5100	4131	5	11	16	5	2.75	3.2
